BL1A T2 Issue

Y.-N. Rao

TRIUMF

Abstract: In this note we review the changes in the elevations of BL1A T2 target and its protect monitor over the last four years, with goal to pinpoint the primary misalignment that causes the reduction of TNF neutron flux.

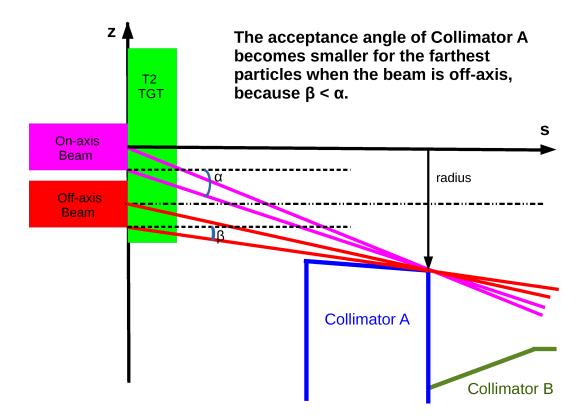
It was suspected that the proton beam was being forced off axis by the T2 Protect Monitor, as a result, a larger fraction of the beam was scraped by Collimator A which has a 1 cm radius entrance aperture. In terms of the REVMOC simulation result (see TRI-DNA-82-3), about 35% of the beam hitting T2 is normally lost on the Collimator A before entering TNF, as the beam size becomes largely blown up due to multiple scattering and nuclear scattering after passing through a 10 cm long T2 target (Be). The scattering angle is about 15 mrad (rms). If the beam enters the T2 target with an offset from Collimator A axis, then the acceptance angle of Collimator A is reduced, thus the furthest off-axis protons are scraped by the Collimator A, leading to the TNF neutron flux reduction. This is sketched below.

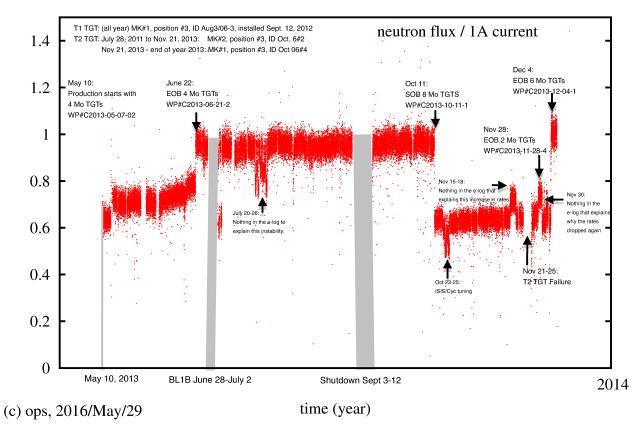
TNF Flux Rate 2013

There were no Moly targets installed in the TNF during the period from 2013-Jun-21 to 2013-Oct-11, over which the TNF neutron flux was reading as high as ~ 1000 counts (which corresponds to the 1 in the above plot) and was almost constant. And then from 2013-Oct-11 to 2013-Nov-28, there were 8 Moly targets installed in the TNF, thus the neutron flux dropped to ~ 650 counts (which corresponds to 0.65 in the plot). This drop was due to the energy reduction of proton beam passing through the Moly targets. Until 2013-Dec-04 when the Moly targets were removed, for a brief time the neutron rate came back to 1000 counts level.

Clearly, during each period, either with or without Moly targets installed in the TNF, the TNF neutron flux could increase or decrease for some reason. Nevertheless, it is making sense for the neutron user to consider the 1000 counts as their reference and desired value for the case without Moly targets.

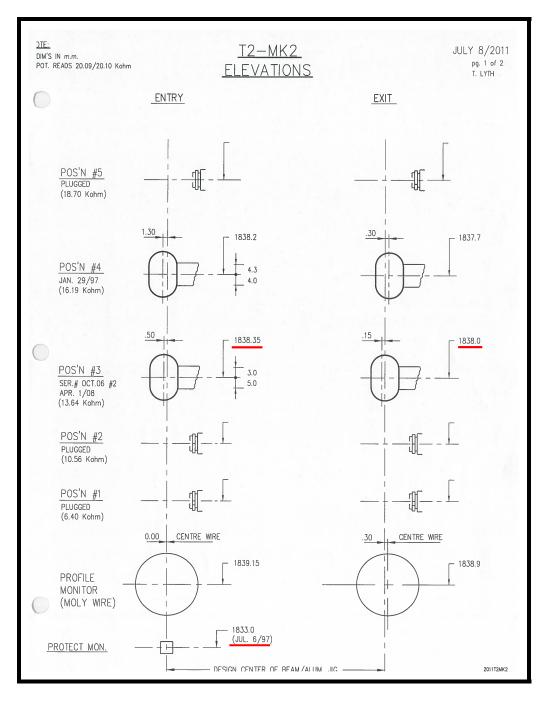
★ Note that during the 1st target period, the Protect Monitor was higher than the target by about 1838.0-1833.0=5.0 mm, and also HIGHER (not lower) than the Collimator A by about 1834.7-1833.0=1.7 mm.

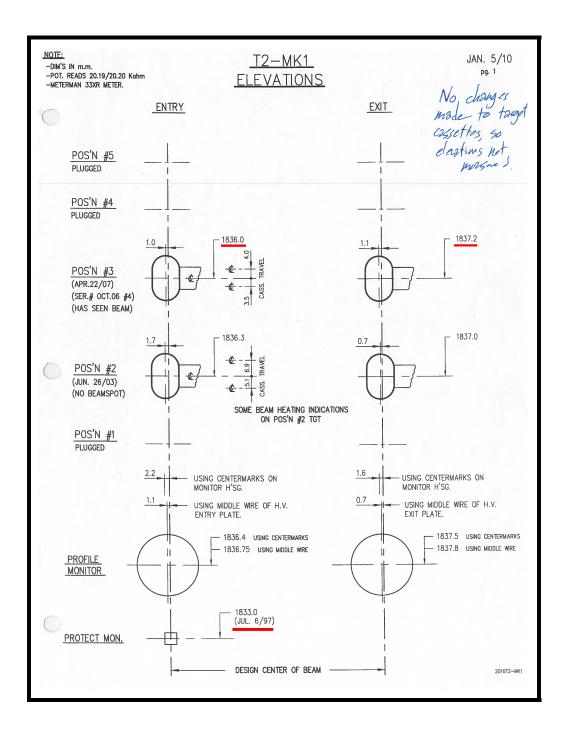
★ During the 2nd target period, the Protect Monitor was higher than the target by about 1836.6-1833.0=3.6 mm, and also HIGHER (not lower) than the Collimator A by about 1834.7-1833.0=1.7 mm.

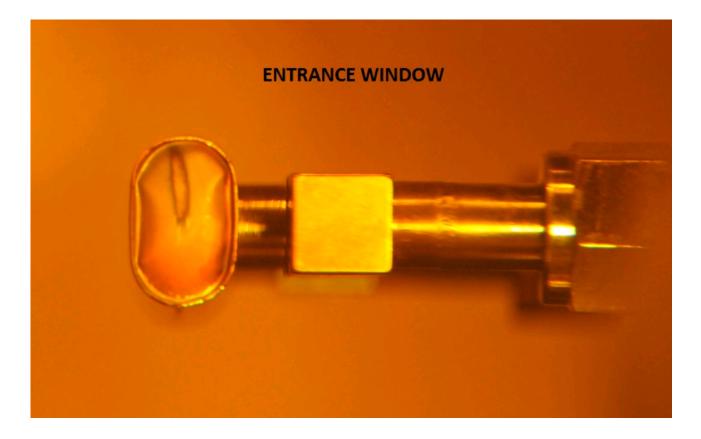
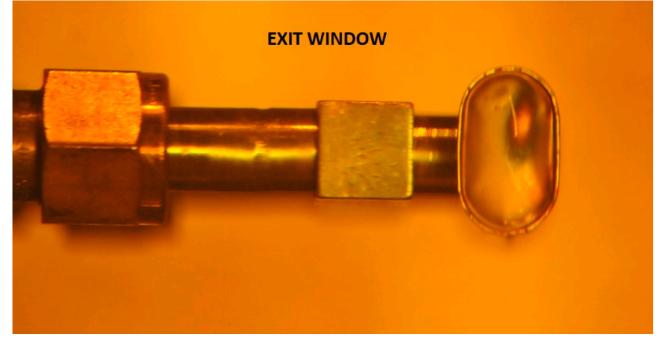
<u>T2-MK2</u> <u>BEAMSPOTS</u>

\bigstar In terms of Isaac's photos and measurements, the beam spot centroid was upward displaced from the target centre-line by roughly 8.5/2=4.2 mm at entrance.

The displacement is roughly the same at the exit window. This indicates that the beam was pretty leveled through the target.

But remember that this beam was kept balanced up and down on the T2 Protect Monitor. Thus, this means that the target centre-line was misaligned by \sim 4.2 mm, too low relative to the Protect Monitor centre-line. This is consistent with the elevation info that Isaac provided, as shown next page, where the target was indicated to be (1838.2+1837.7)/2-1833.0=5.0 mm lower than the Protect Monitor. Note that the bigger number here means a lower elevation as the zero value is on the top.

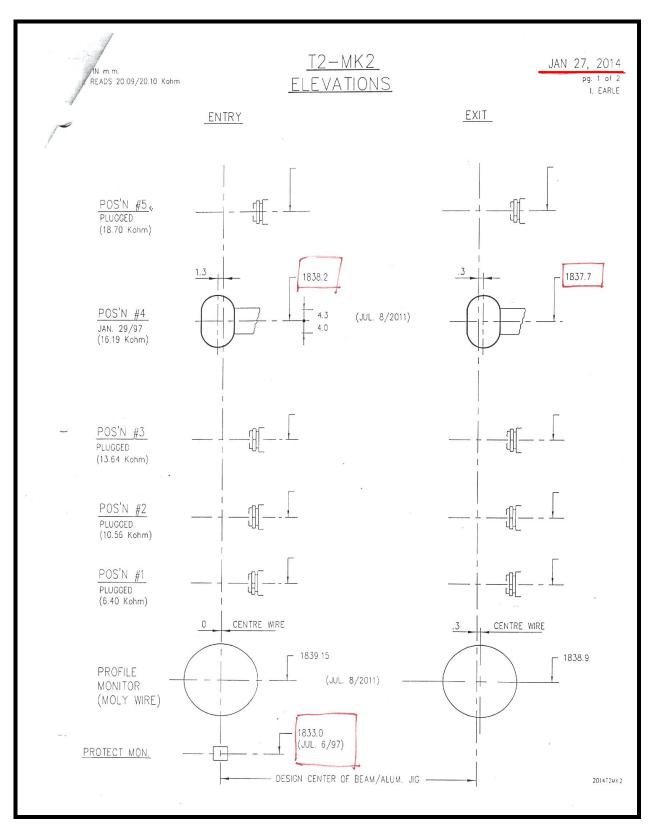
It indicates that the target was lower than the protect monitor by (1838.2+1837.7)/2-1833.0=5.0 mm.

★ The target should be elevated by 4.2 mm to be flush with the Protect Monitor. But what actually happened was that the Protect Monitor was lowered by 6.8 mm, instead of the target being elevated. See the following Isaac's entry on the RH e-log of 2014-May-02.

The correct adjustment should be elevating the target by 4.2 mm instead of lowering the Protect Monitor by 6.8 mm.

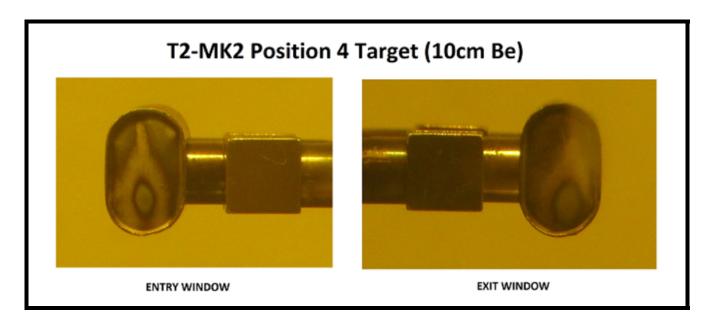
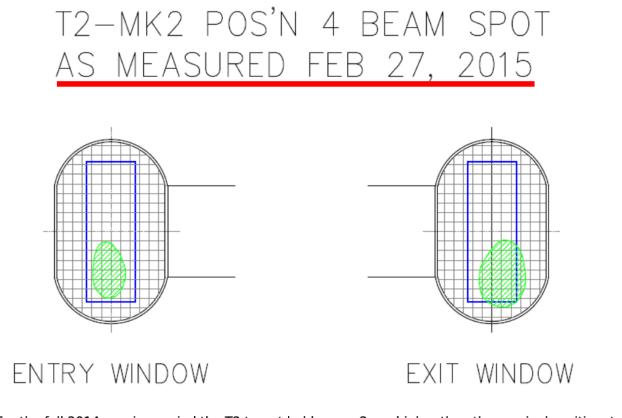
Here are plots of the entry and exit window beam spots with the outline of the beryllium material shown in blue. The grid spacing on the target window is 1mm. As you suspected, part of the beam is missing the target at the exit.

For the full 2014 running period the T2 target ladder was 2mm higher than the nominal position, to try to compensate for steering issues (the issue was corrected in October 2014, but the ladder position was not changed). The plot below shows the beam spots shifted up 2mm. This is what I would expect if the target ladder was set at the nominal position and beam tune was not changed. In the plot below the beam spot centers seem to be about 2.5mm below the target center, this indicates to me that the T2 protect is 2.5mm too high.

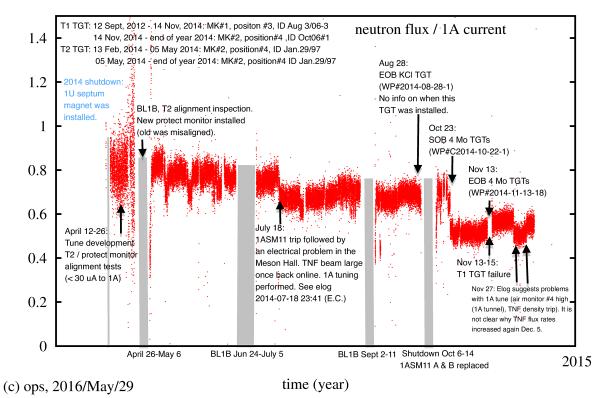
TNF Flux Rate 2014

★ As a result of that, the TNF neutron flux dropped below 600 counts. This drop was very significant, starting from 2014-Oct-22, even until 2014-Nov-13 when the Moly targets were removed. See the following plot.

★ In conclusion, from 2014-Oct-21 to the end of 2014, the T2 Protect Monitor which was sitting at elevation of 1833.0+6.8=1839.8 mm was lower than the Collimator A which was sitting at 1834.7 mm by 5.1 mm. This was responsible for the neutron flux getting significantly dropped below 600 counts.

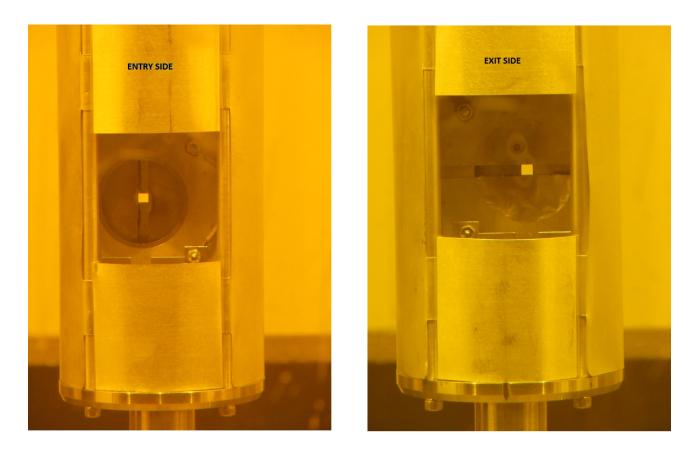
Photos of the Protect Monitor used for the 2014 production run.

Clearly, there were 2 heat marks noticed on the exit side: one was significantly above the plate centre, the other was flush with the gap.

★ On 2015-Apr-23, a new Protect Monitor was installed with its elevation upward adjusted by 2.9 mm relative to the old one used over the previous year from 2014-May-05 to 2014 Christmas shutdown.

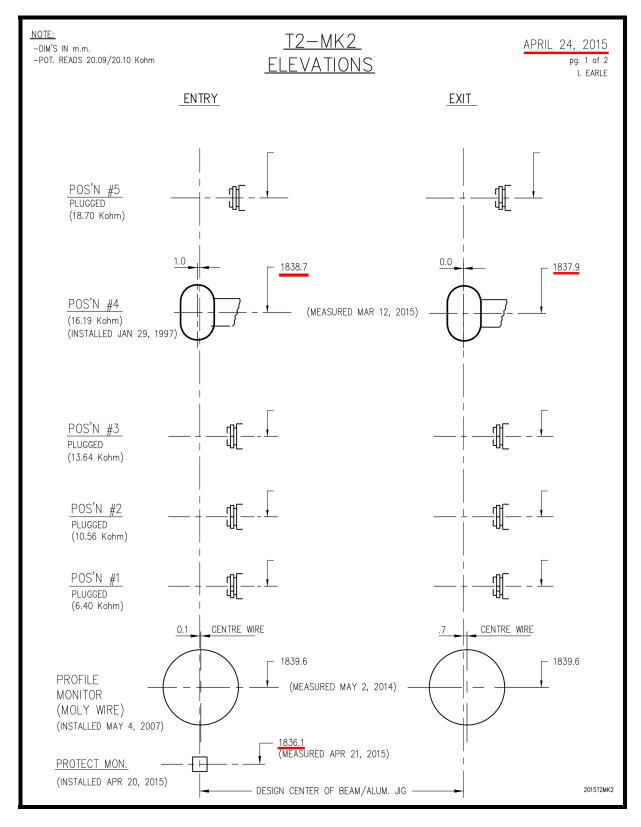
It indicates that the Protect Monitor was higher than the target by (1838.7+1837.9)/2-1836.1=2.2 mm.

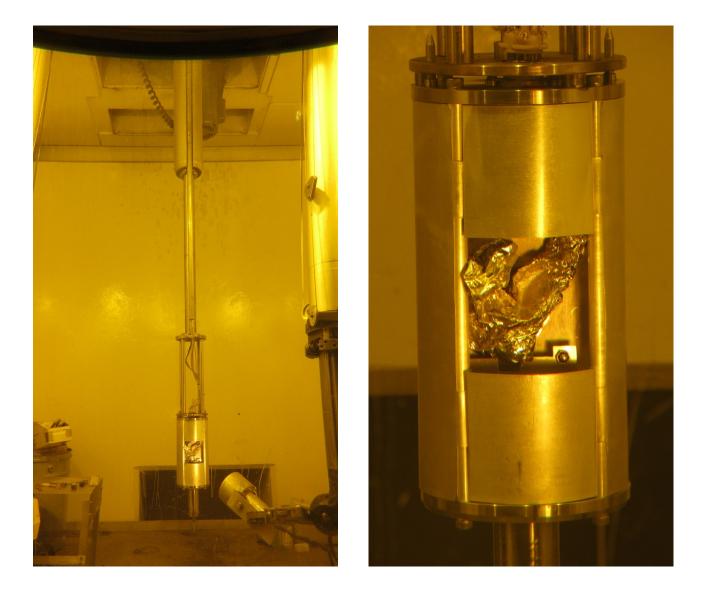
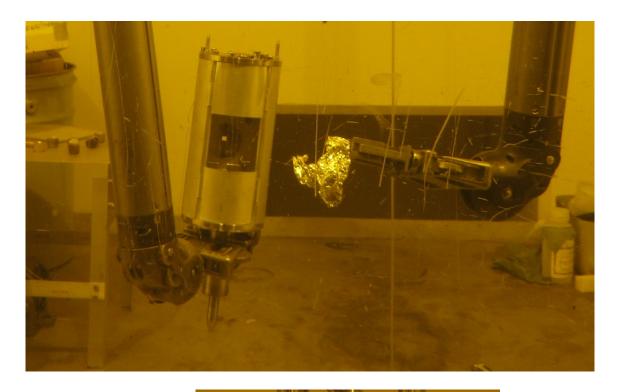
- Monitor inspected: a thin piece of foil was found jammed into the entrance side of the monitor (see photos) & a heat or burn mark was seen on the exit side above and to the south of the plate gap. It is suspected that this material traveled down the beamline at high speed when there was a vacuum burst during the September shutdown. In light of this information it was decided to remove the T2 target and T1 target as well (see following e-logs)

A thin piece of foil was found jammed into the entrance side of the monitor :

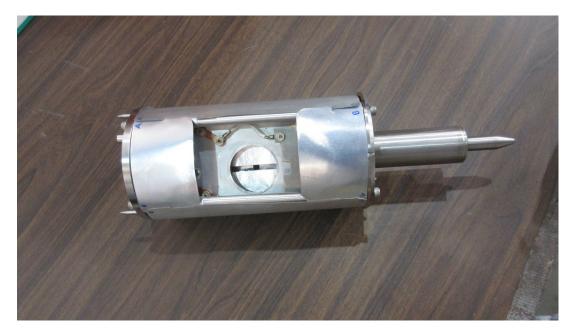
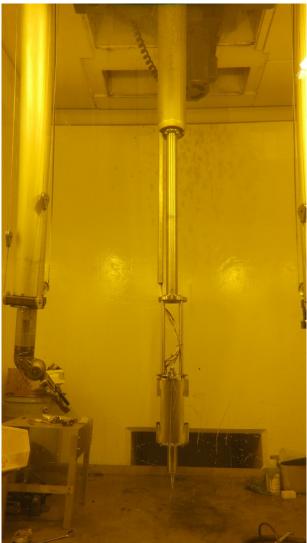
And a heat or burn mark was seen on the exit side above and to the south of the plate gap. ==>

To replace the damaged protect monitor, a new one was put in.

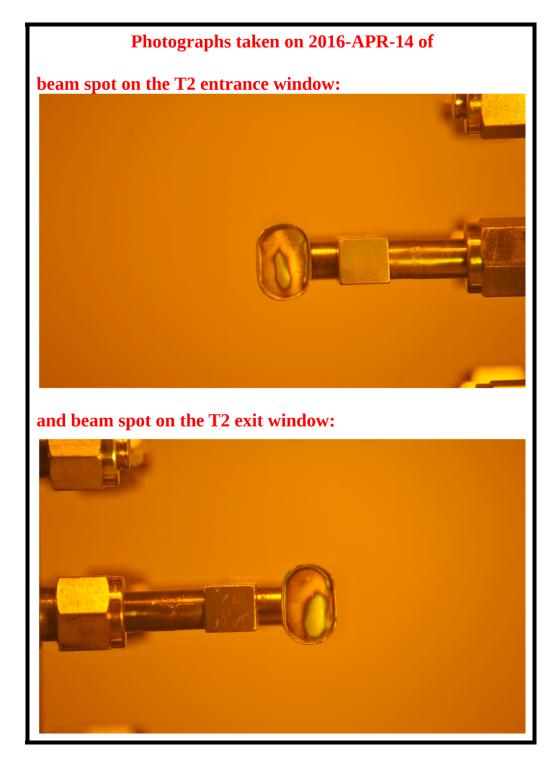
Similar to the pictures of Oct. 2015, overall the spots were low on the target.

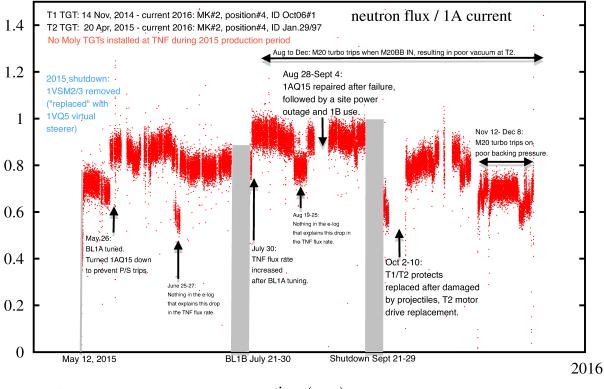
TNF Flux Rate 2015

★ Noticed that during the period from 2015-May-12 (when 1A just started up to take beam) to 2015-Sept-20 (when the mini shut-down started), the TNF neutron flux overwhelmingly exceeded 800 counts, and even reached 900 over 3 periods, namely, from May 26 to Jun.24, from Jul.30 to Aug.18, and from Sept.4 to Sept.20.

Coming out of the repair, the neutron flux had around 800 counts, not so bad. But, from Nov.12 to Dec.8, it dropped below 800.

★ These fluctuations in the neutron flux were just related to the fact that the beam spot was shifted up and down on the target, because there were no Moly targets installed at TNF during 2015 production run.

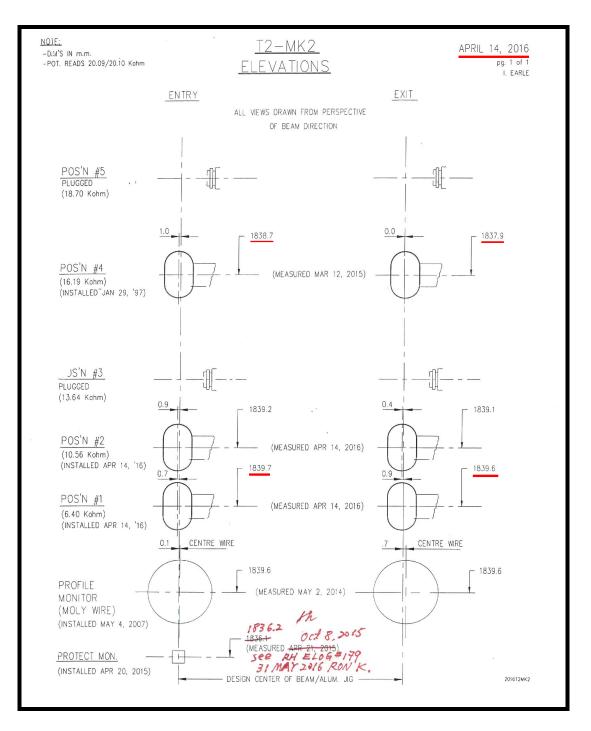
Noticed that the Protect Monitor was higher than the target Position #4 by (1838.7+1837.9)/2-1836.2=2.1 mm, and higher than the Position #1 by (1839.7+1839.6)/2-1836.2=3.5 mm, but still LOWER (not higher) than Collimator A by 1836.2-1834.7=1.5 mm. ★ On 2016-May-13, the T2-MK2 target Position #4 started to take beam. From the start to June 1, the neutron flux was constantly reading as low as 600 counts.

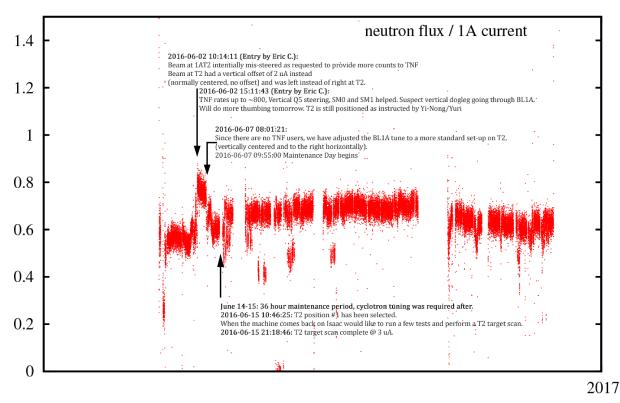
TNF Flux Rate 2016

★ On June 2, Eric Chapman intentionally mis-steered the beam as requested to provide more counts to TNF. Eric had to let the beam position be high vertically and be left horizontally on the T2 Protect Monitor in order to increase the TNF counts up to 800.

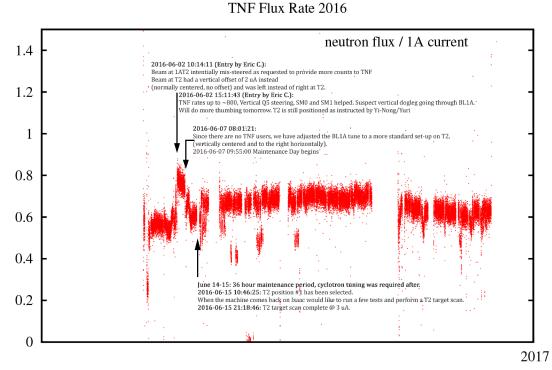
But, from 2016-June-15 to the end of 2016, the TNF neutron flux constantly stayed below 800 counts. During this period, the beam was kept balanced vertically and to the right horizontally on the T2 Protect Monitor.

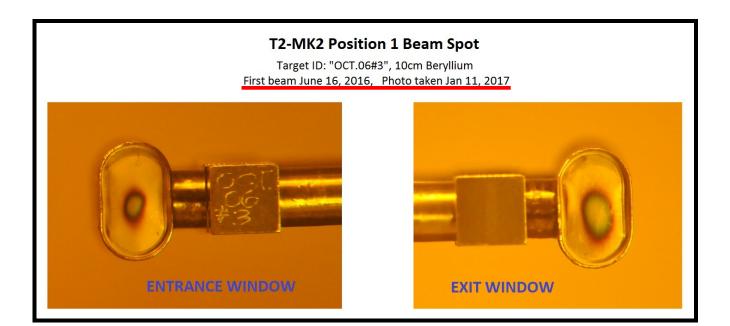
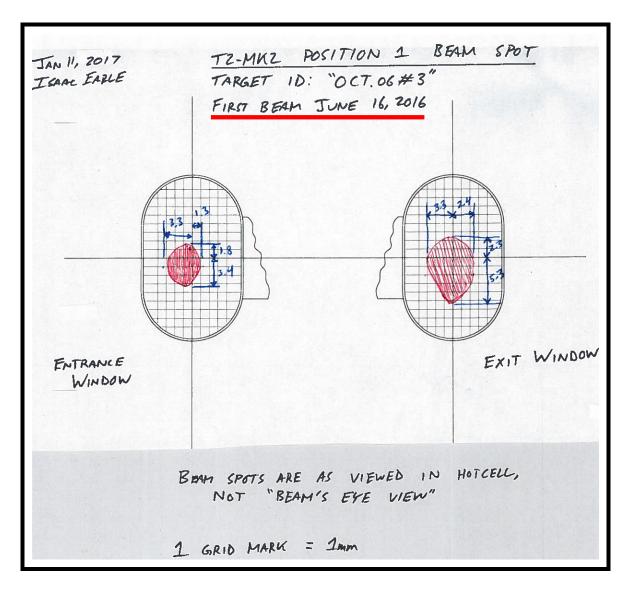
The beam spot on the 10cm beryllium target in Position 1 on T2-MK2 (Target ID: "OCT.06#3") was measured and photographed vesterday. A fairly well centered spot was measured to be approximately 4.6mm wide x 5.2mm tall on the entrance window and 5.7mm wide x 7.6mm tall on the exit window using the Nikon micrometer level. This target first saw beam on June 16, 2016.

(1.8+3.4)/2 -3.4=-0.8 mm at entrance,

$$(2.3+5.3)/2$$
 -5.3=-1.5 mm at exit.

The offset was about 0.7 mm downward, suggesting that the beam was angling downward by 7 mrad onto the T2 target as the target was 10 cm long. At least in terms of the angling direction being downward, this angle was consistent with the elevation difference between the Protect Monitor and the target, which was (3.5+0.8)mm/(32-5)cm=16 mrad.

★ Since we have no real-time measurements about the position and incident angle of beam entering the target, and bear in mind that the beam just wanted to be higher on the Protect Monitor to produce > 800 neutron counts, we've decided to elevate both the Protect Monitor and the target by 3 mm from where they are. Specifically, they shall be set to the following elevations:

T2 Protect Monitor centre-line: 1833.5 mm, w.r.t. the T2 target flange.

T2 target centre-line: 1836.5 mm, w.r.t. the T2 target flange.
